Home Inspection Report

77 Hastings Avenue, Toronto

Prepared by
APG Home Inspections
Adrian Guertin, PMP, CMI, CCHI
www.apghomeinspections.ca

PRE LIST HOME INSPECTION:

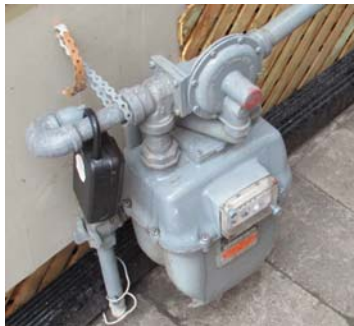
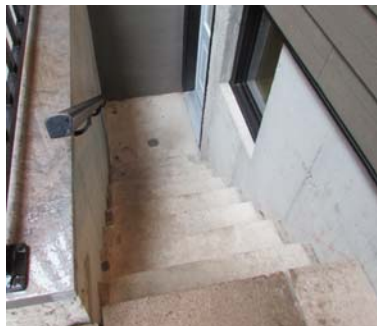
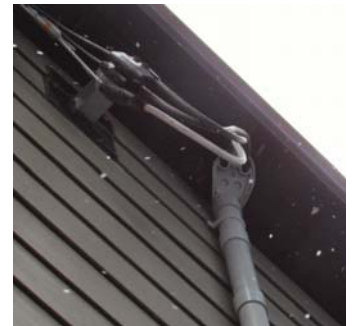
- 1- Gas Service to House 1" Feed
- 2- Keep Walkout Clear of Debris
- 3- Overhead Service - Secure

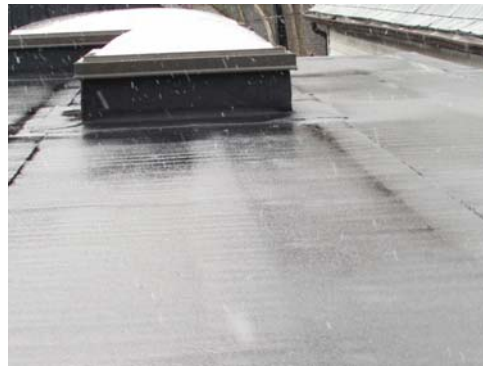
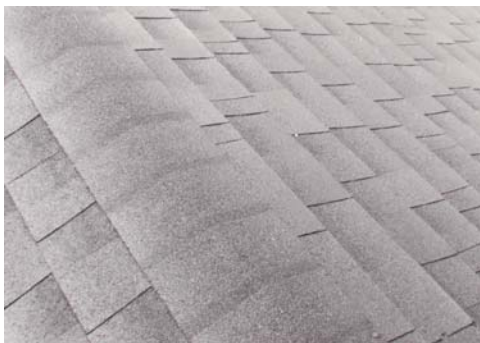
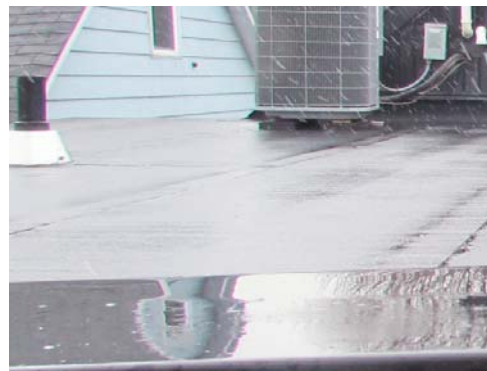
Newer Architectural Shingles
Torched Membrane - Flat Roll Roof
Good Overall Condition

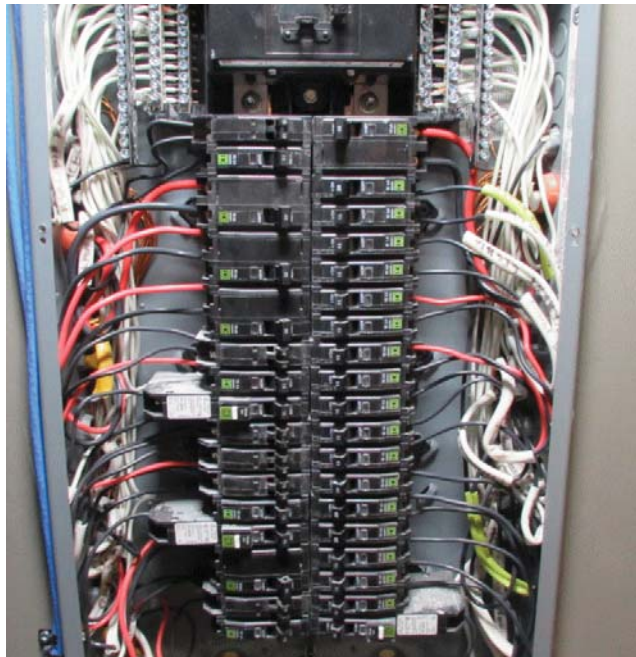
Electrical Panel Branch Wiring

200 Amp Service
Copper Wiring
Good Overall Condition

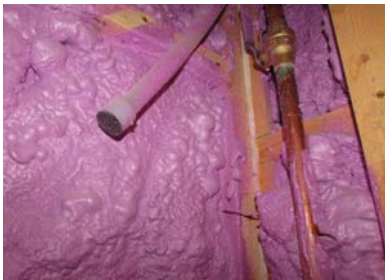
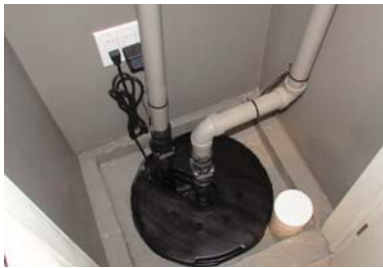
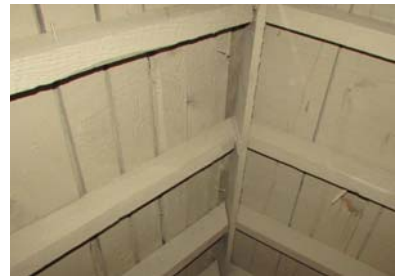
- 1- Insulated Exterior Walls and Windows With Spray Foamed Insulation
- 2- Sump Pump in NE Corner - Storm Water Management System with Check Valve
- 3- Attic Sheathing - Planks - DRY

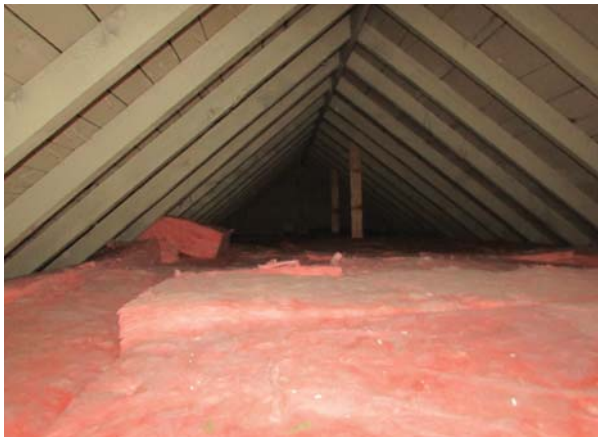
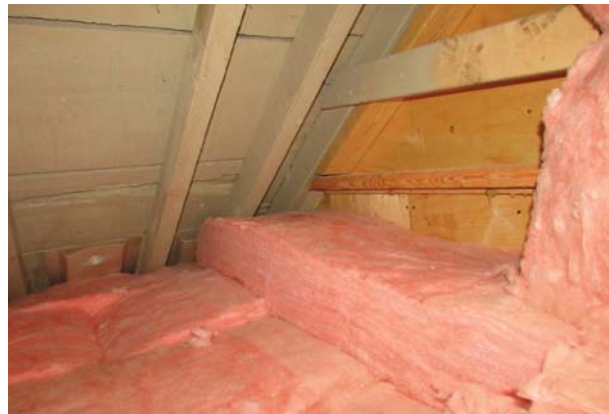
Fiberglass loose Fill x 2 Layers of R22 Bats
Estimated R Value 40+/-
Sheathing Dry - Venting Good

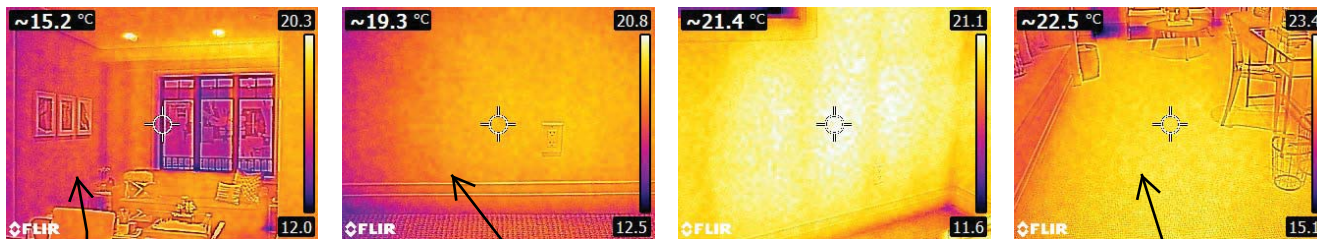
exterior walls well insulated

Basement dry... well insulated

Basement has radiant in floor heating

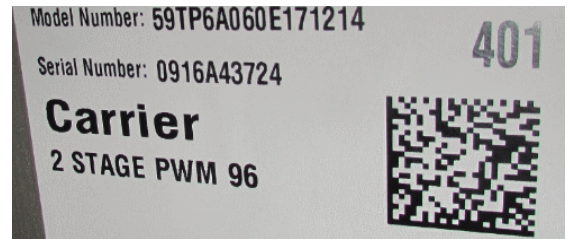
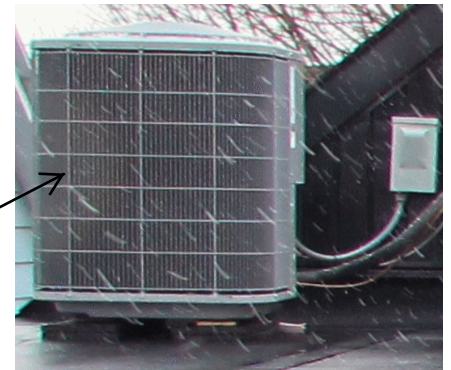
AC compressor access through skylight or from 20' ladder

Newer Furnace and AC
 Newer Tankless HW System
 Good Overall Condition
 Change Filter Every 3-4 Months 16x25x1
